## GlassCoat

### Efficacy Test and Report

## Test: **Durability of Glasscoat** using an **Accelerated Weather test.**

# **Accelerated Weather Test Comparing HBC System - Glasscoat to Seven Other Products**

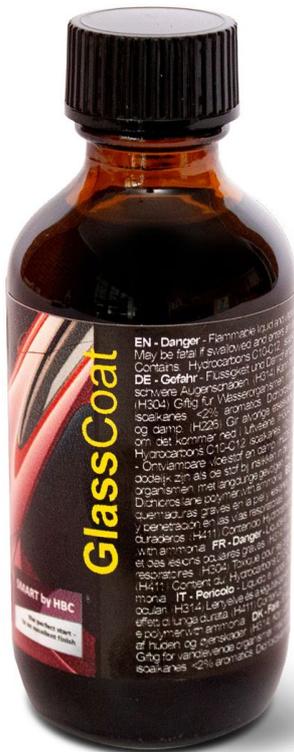
*GlassCoat protects paint finishes against damage from machine car washes, environmental conditions for up to a 7 year period! GlassCoat is a ceramic glass resin, that when applied to your paint provides a permanent bond that protects and guarantees your vehicle's finish from environmental conditions not covered by the manufacturer's warranty.*

*GlassCoat is a clear liquid that is applied to the clearcoat of your vehicle. Unlike traditional waxes and sealants that simply "coat the surface", GlassCoat polymerizes and crosslinks onto the surface of the clear-coat. The end result is a clear and extremely durable ceramic film that adheres so strongly to the surface that not even organic solvents can remove it.*

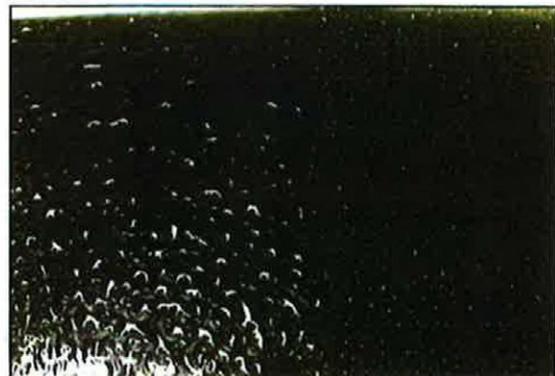
*The Uncoated left side is easily distinguished from the Coated right side. The coating is Auto Armor.*

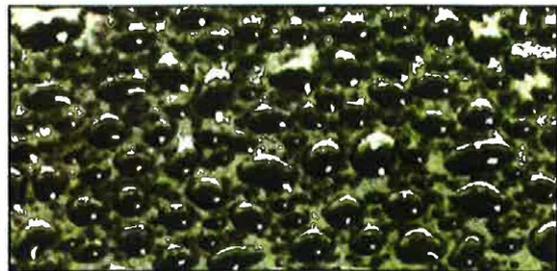
*Fig. 2 Glasscoat 1750 hours (detail)*

The coating's hydrophobic character forced the excess Spray Solution to the uncoated half or off the edge. The close-up photo (fig. 2) indicates that the liquid beads still retain their circular base.

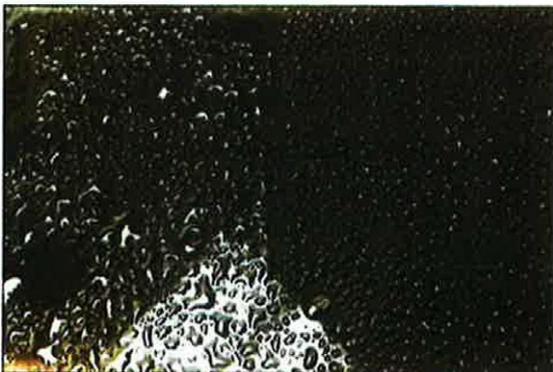
*Fig. 3 Auto Armor at 250 hrs*

Water repellence at 250 hours was clearly evident (fig. 3). The beads themselves have begun to take on an amoeba-shaped base (fig. 4). At 500 hours, the distinction between Uncoated/Coated halves is

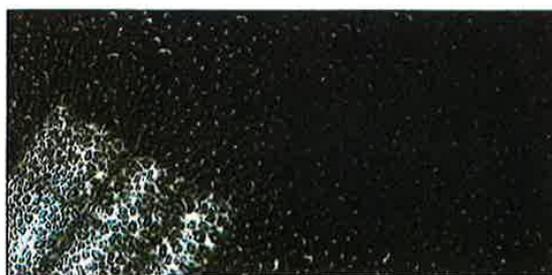
*Fig. 9 PermaPlate Paintguard 0 hours*

Water repellence at initial application was so poor that it was impossible to distinguish the Coated half of the panel from the Uncoated half (the left half in the photo) (fig. 9). It was possible to discern a difference in the rate at which water flows off the panel when tipped. Figure 10 shows water has flowed

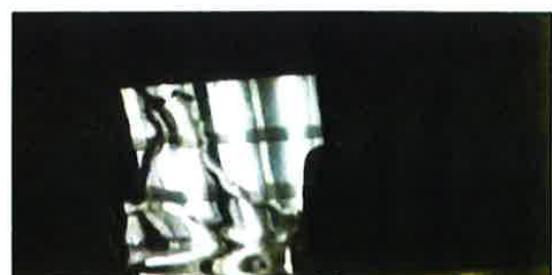
off the coated half, while about a quarter of the initial volume on the uncoated half remains in the instant that the picture was snapped. At 250 hours, it was impossible to discern a difference in water-shed rate between the two halves.

*Fig. 10 Water sheds slightly faster from the Coated half]*

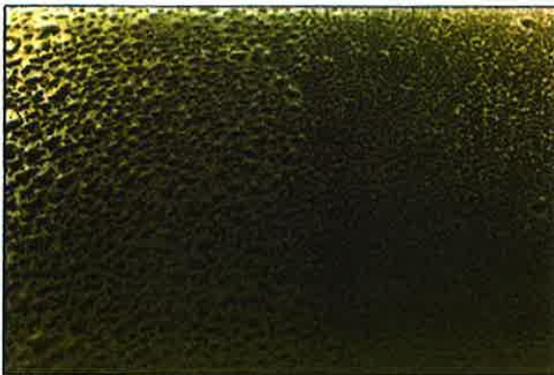
*Fig. 18 Xzilon Orange at 250 hours*

Water repellence at 250 hours (fig. 18) and at 500 hours (fig. 19) is sufficient to clearly distinguish the uncoated and coated halves. At 750 hours, water repellence of the coated half had degraded to the point that it was impossible to distinguish coated from uncoated (fig. 20).

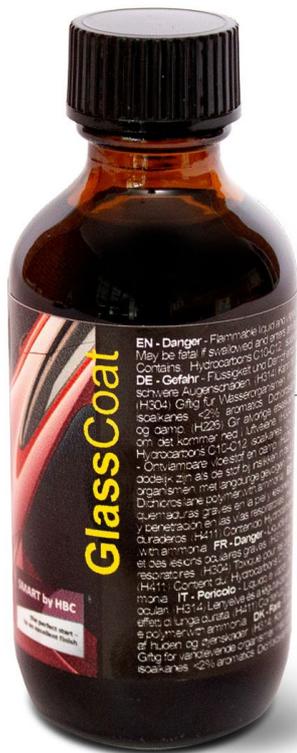
*GlassCoat protects the painted surface of the vehicle when minor dings occur. The coat is designed to enhance customer loyalty, protect the investment of customers' vehicles and create an additional revenue stream that increases profitability for body shops.*

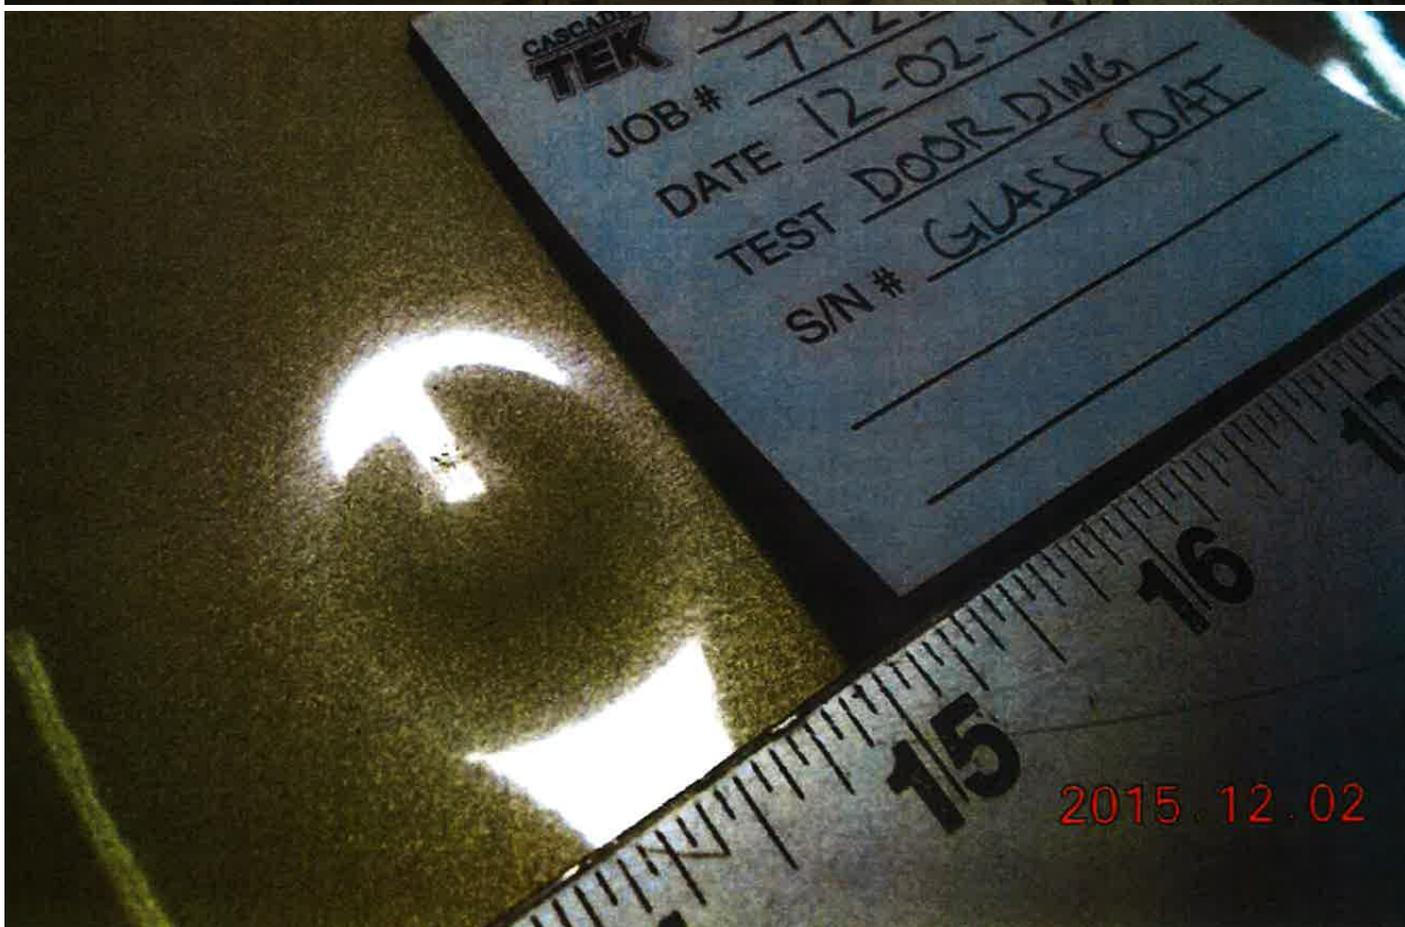
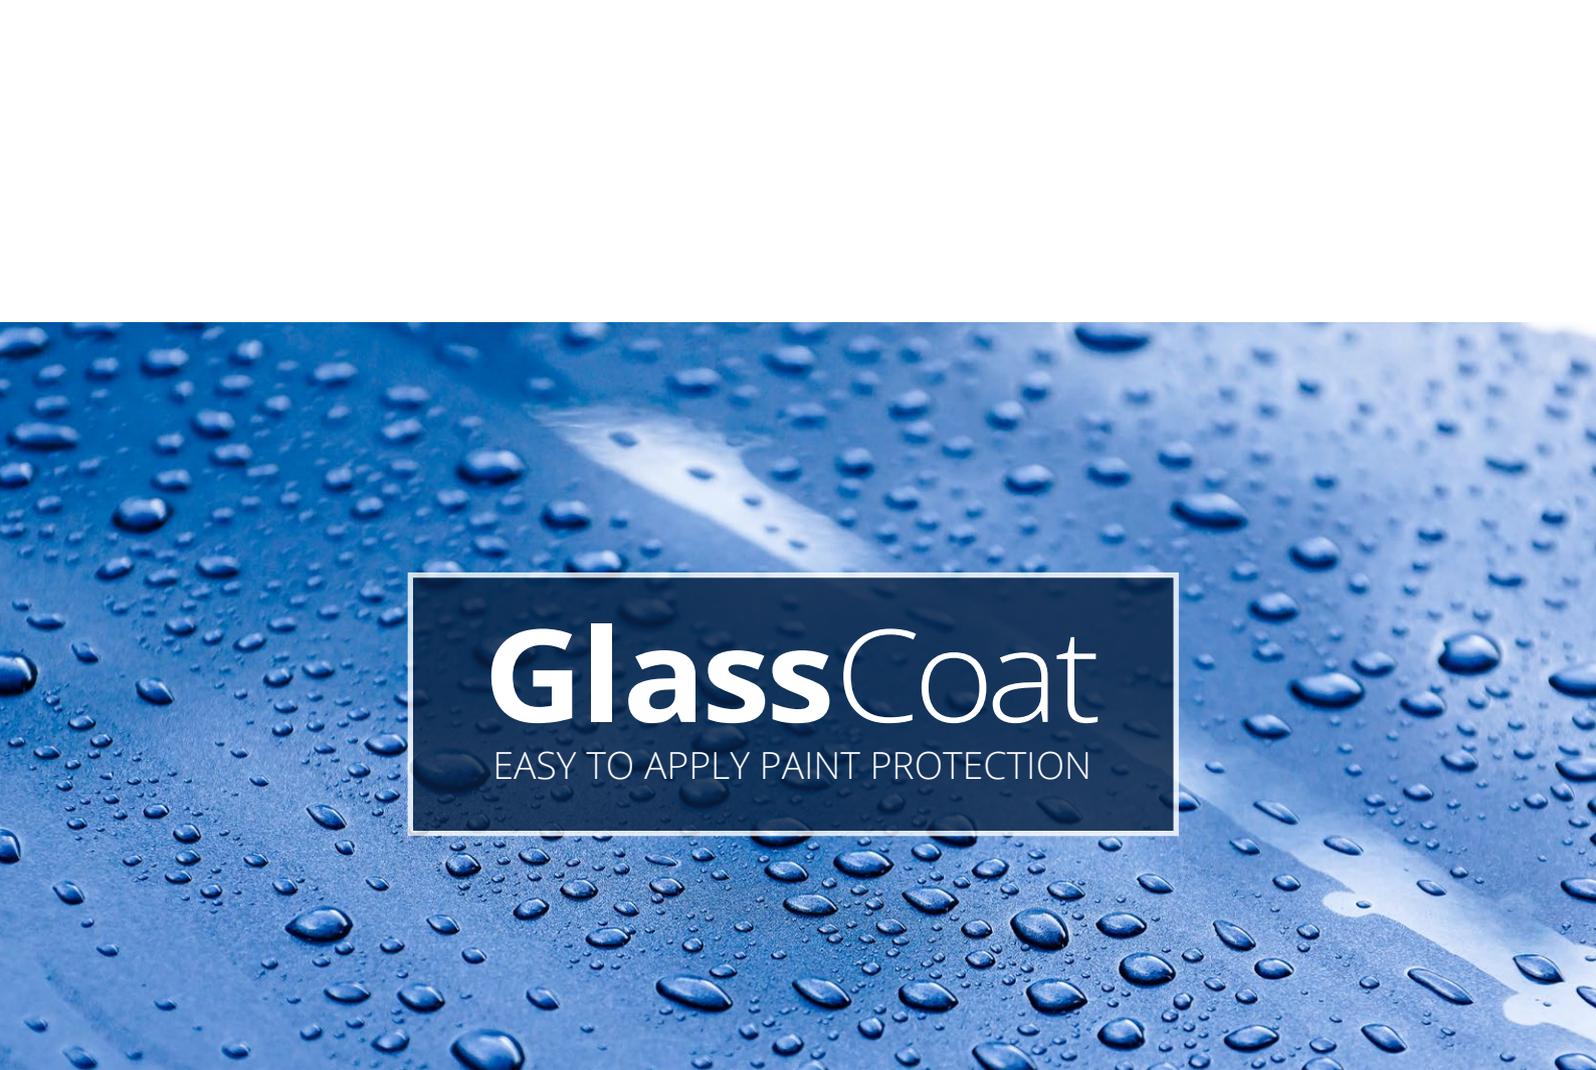
**The Test Result:** The dropped cylinder produced a golf ball sized ding approximately 1.5 inches in diameter. HBC GlassCoat protected the paint with chipping or cracks and only light abrasions. These light abrasions were easily buffed out with traditional detail methods .

BP	12/2/2015	0959	Drop complete. Door ding photographed with light abrasion noted. Photos taken and stored for customer evaluation.	<input checked="" type="checkbox"/>
Test Complete
